Cliff Stabilisation Works and Management – at Sidmouth, Devon

Connaught Gardens Cliff at Sidmouth, formed in characteristic red Otter Sandstone, is very steep, locally overhanging with small caves. The Millennium Footpath which links the Sidmouth Town and Jacobs Ladder beaches passes along the base of the cliff with a further footpath along the cliff top. East Devon District Council commissioned David Roche GeoConsulting to advise on potential instability risks and then to design and supervise the stabilisation works.

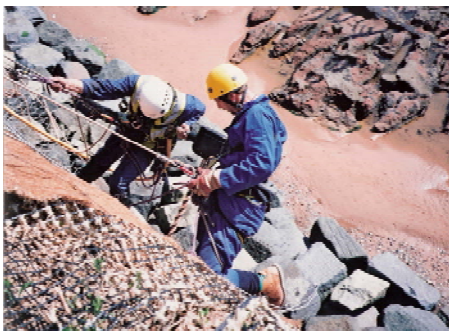
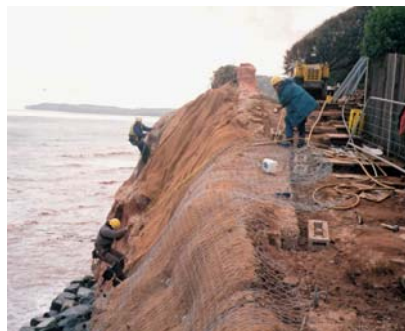
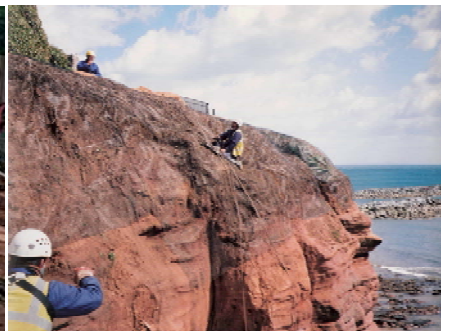
Engineering geological investigation of the cliff was carried out by rope access inspection. This revealed that most of cliff in sandstone bedrock was generally sound subject to scaling of loose materials. Along the upper cliff, loose soil and vegetation presented risks of debris falls, and at the eastern end a length of wall along the cliff top path was found to be at risk of toppling.

Stabilisation works included vegetation cutting along the top of the steep cliff slopes, removal of loose or potentially loose soil and rock from all the cliff faces, followed by reinforcement of the upper cliff slope with rocknet fixed to rockbolts, with additional spot bolting on the rock faces to fix individual blocks at risk of becoming unstable in the future. The cliff top wall at the eastern end was taken down, and new beam foundations were underpinned with mini-piles prior to reconstruction.
