Ground Investigation and assessment in Romsey, Hampshire
– cost effective assessment for residential development

A phased investigation was carried out on a former garage and timber yard in Romsey proposed for redevelopment to residential housing. The developer required a comprehensive investigation to address ground engineering, and potential contaminant concerns. The desk study highlighted potential poor ground conditions and past contaminative uses. The intrusive investigation was specifically designed from the desk study findings saving time and money by preventing unnecessary investigation and testing. Working closely with the project manager, structural engineer and analytical laboratory, a staged investigation and assessment produced the required outcome for the developer in a cost effective, and time efficient manner.

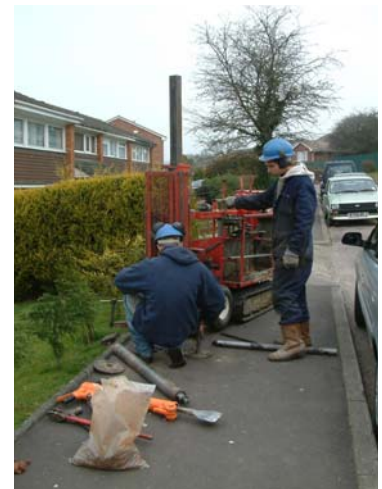
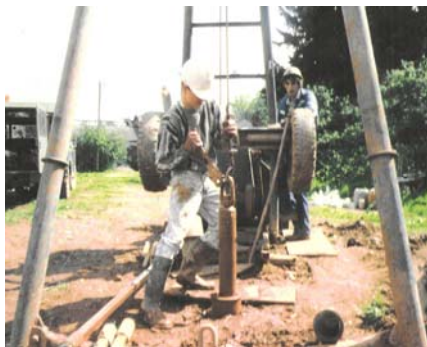
The intrusive investigation comprised of dynamic probe window sample holes to determine shallow ground conditions and contamination extent. Exploratory holes and samples were screened on site for volatiles including hydrocarbons using a photo-ionisation detector (PID). Cable percussive boreholes were required to determine the ground conditions for deep foundations.
